# Kinver Case Study

**Project:** Kinver 24"Pipe Bridge Burst Watermain

**Location:** Situated on an island in the River Stour, to the rear of The Hyde, Kinver

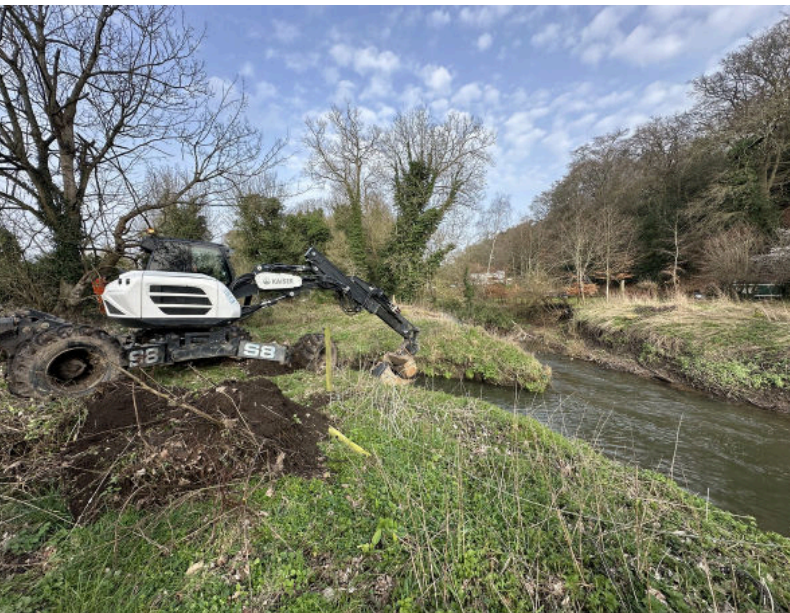
Excavate around the 24-inch water main to facilitate the installation of an encapsulation collar over the leaking joint, ensuring safe access, proper alignment, and effective sealing of the defect.

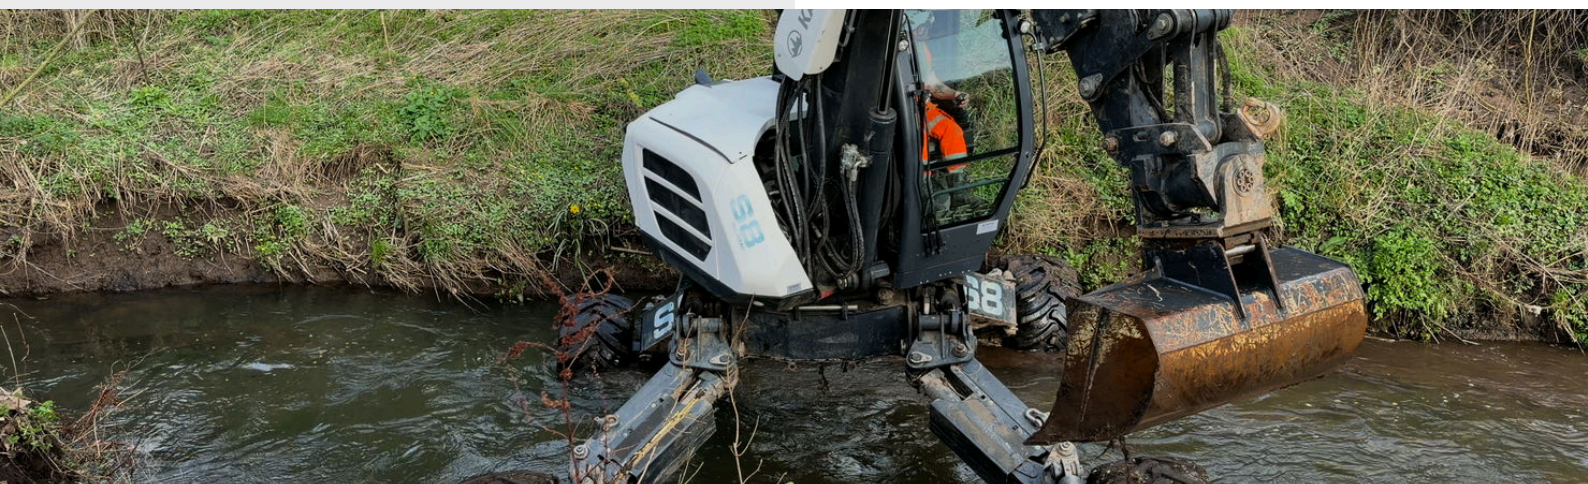
- A team of specialist tree surgeons was deployed to safely remove trees and dense vegetation, creating a suitable access route for excavation works.
- Access for machinery was carefully planned and agreed via a local leisure centre car park located approximately 300 metres from the burst location, utilising an existing dirt track running adjacent to the river.
- A specialist contractor supplying Kaiser S8 Spider excavators was engaged, attending site to assess and confirm a safe method of navigating the dirt track and traversing the river by negotiating the steep banks on either side.
